SCREENING FOR COUNTERFEIT ELECTRONIC COMPONENTS

Stephen Schoppe and Glenn Robertson
Process Sciences, Inc.
Leander, TX, USA
glennr@process-sciences.com

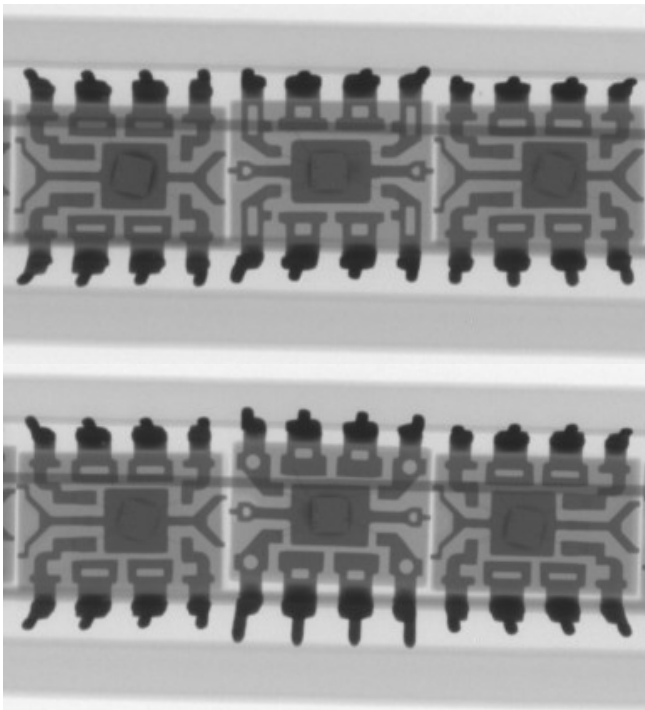
X-ray Inspection of Components in Packaging
Note That Components in Center Do Not Match Others

If necessary, X-ray inspection can often be conducted without removal of the components from their packaging. All of the components in a shipment may be non-destructively inspected for any internal variations among the individual components. In some cases, the process can be automated using the step-and-repeat function provided in some operating software.

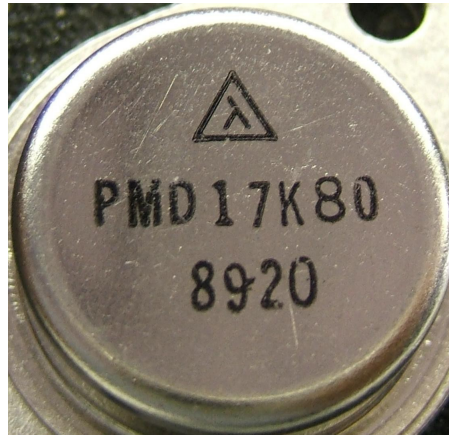
Component As Received

The appearance of the printing and symbology of the parts to be tested matched exactly with that of the “gold” part.

Three 2-lead TO-46 metal can packages were received, consisting of one “gold” (known-good) part, and 2 sample parts to be tested.

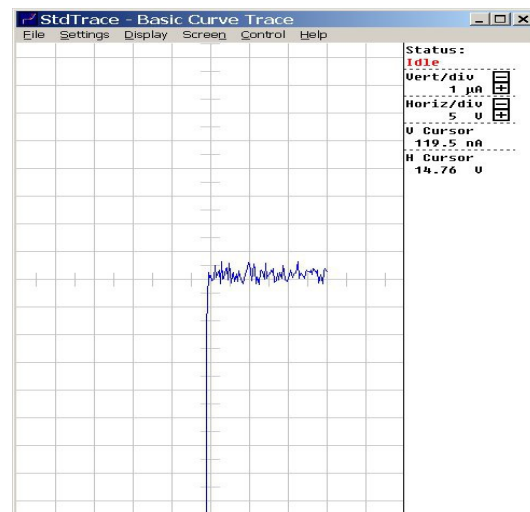
“Gold” Base to collector

All three parts were then characterized by curve tracer, with results as show below.

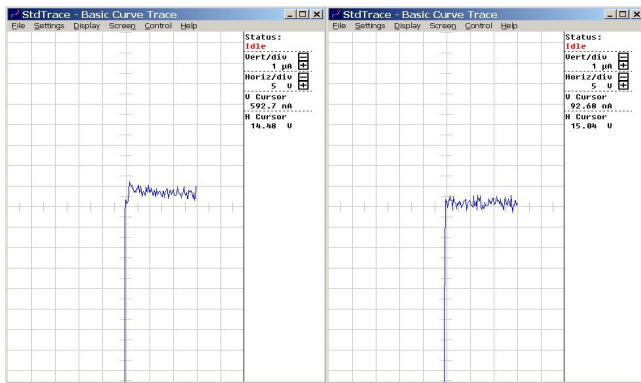
Sample 1 Base - collector Sample 2 Base - Collector

Sample part 1 was consistent with the “gold” part, but Sample 2 is clearly faulty, with high emitter to collector leakage, and open connection between base to emitter.

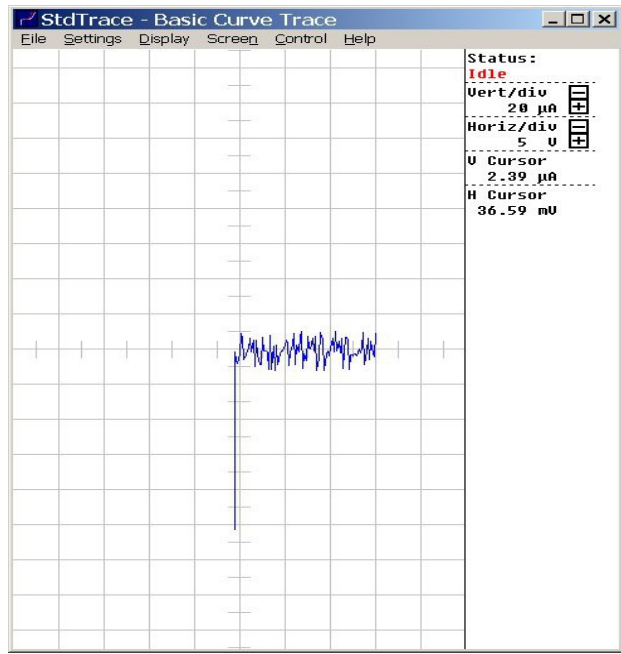
“Gold” (base to emitter)

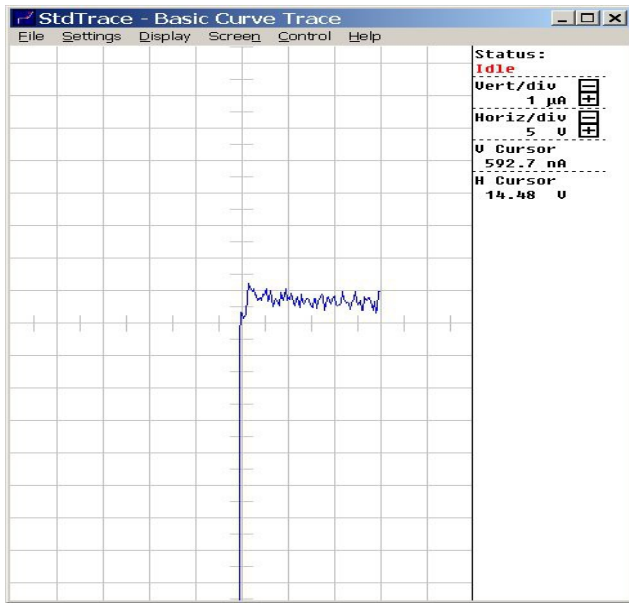
“Gold” emitter to collector

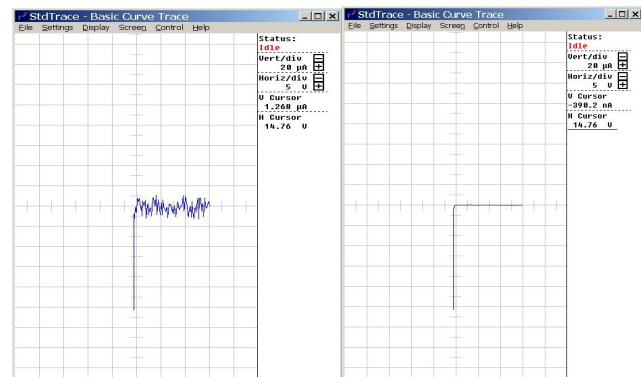
Sample 1 base - emitter Sample 2 base - emitter

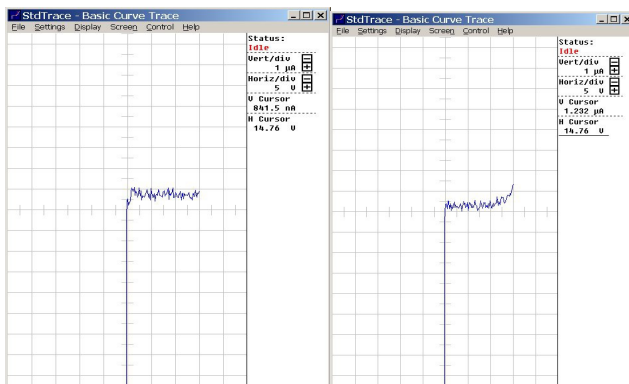
Sample 1 emitter - collector Sample 2 emitter - collector

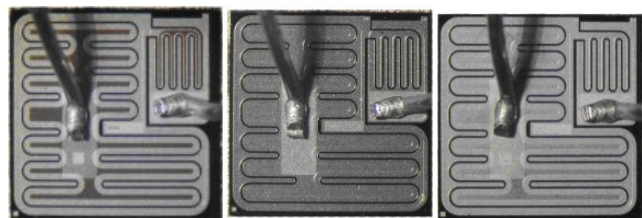
All three parts were de-lidded to examine the surface of the silicon chips. No part number or lot code markings were found on any of the chips. Surface coloration was different for all three, but circuit artwork was similar for all.

“Gold” chip Sample 1 Chip Sample 2 Chip

It was concluded that both sample parts were genuine, with sample 2 being an electrical failure.

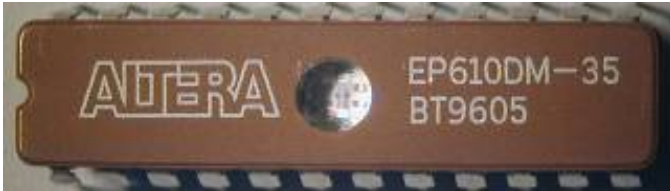
Two plastic DIP packages were received for evaluation. No evidence was found of tampering, and the markings passed permanency testing.

Component As Received

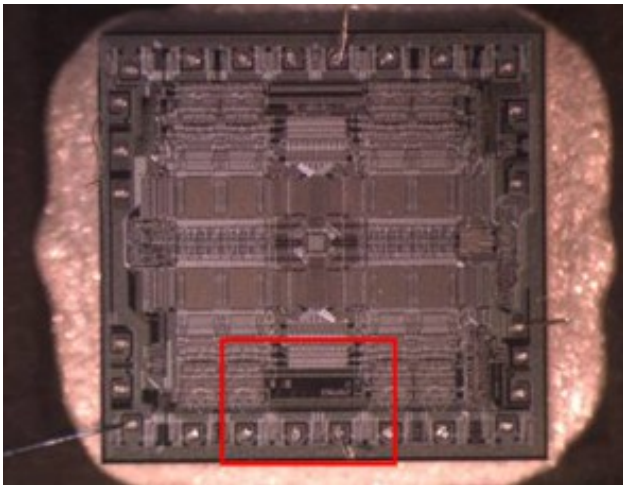
The packages were decapped in order to examine the surface of the Silicon chips. The chips were found to be almost identical, except for the area shown in the close up pictures.

Chip Surface

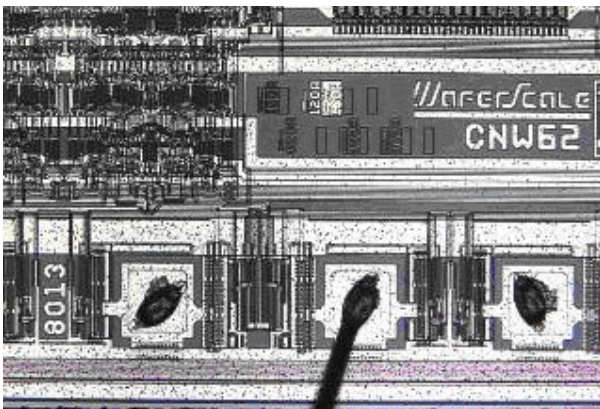
In package number 1, the chip includes "WaferScale" in the artwork, while the second chip has only the letter "D." This indicates that the chips are probably from different fabs or from different revisions. Ordinarily, packaging houses do not mix chips from different fab lines or different revisions without changing the lot code, as this practice compromises traceability.

Package 1 Chip Marking Close-Up (Red Square)

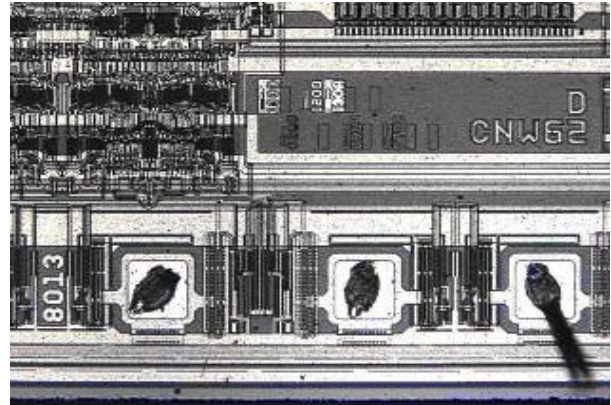
Package 2 Chip Marking Close-Up (Red Square)

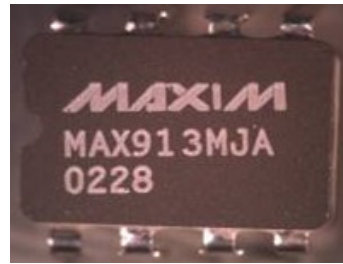
Component Topside Markings

One 8-pin DIP package was received for evaluation. The package markings passed marking permanency testing. However, the leads were non-uniform, with evidence of re-tinning.

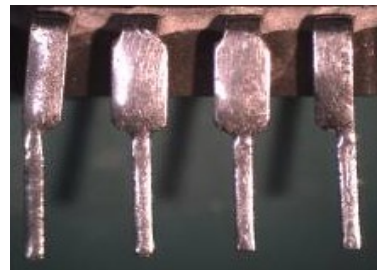
Component Leads

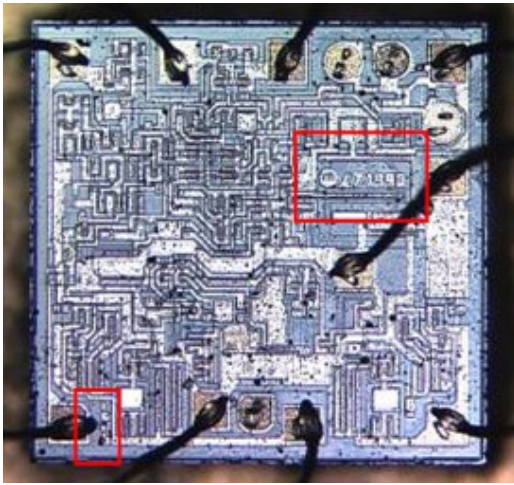
Chip Surface

Following decapping, the chip manufacturer's logo, date code, and part number were identified. The first close-up picture shows a chip date code of 1990, and the second shows a chip ID of "1016."

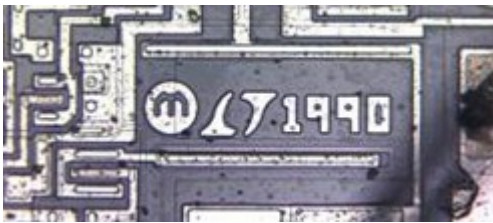
Chip Manufacturer Logo and Date Code

Chip ID Number

These correspond directly to an earlier Maxim part number LT1016, which was replaced with an improved part, designated AMX913. The data from the chip surface indicates that this part is an LT1016 that has been remarked to a MAX913.

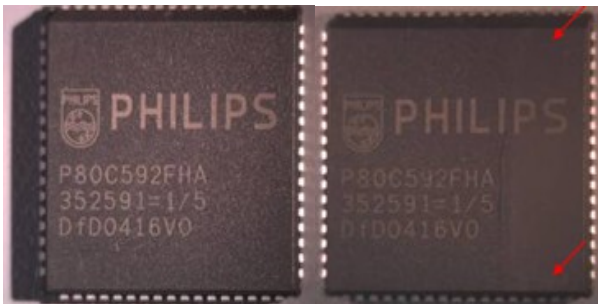
Two 68-pin PLCC components were received for evaluation. Both parts had the same markings, etched into the top surface. Acetone removed the textured surface on both components, thus indicating that the parts have been black-topped and remarked.

Component As-Received

After Solvent Test

However, black-topping of the components indicates that the part has been remarked, possibly to alter the date code, or to show a different variant of this part type.

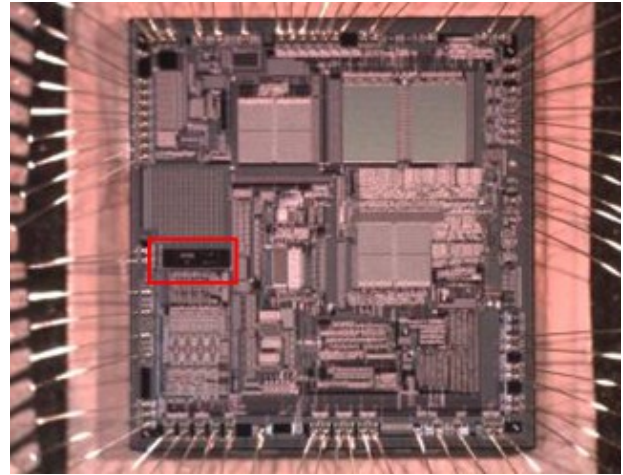
Following decapping, both parts were found to have the same chip, with the Philips logo, and the alpha-numeric marking "V83C592VO" which corresponds to a portion of the external part number marking. This appears to be the correct die for this part number.

Chip Surface

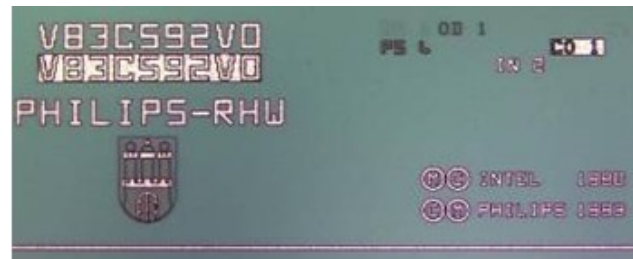
Chip Marking Close-Up (Red Square)

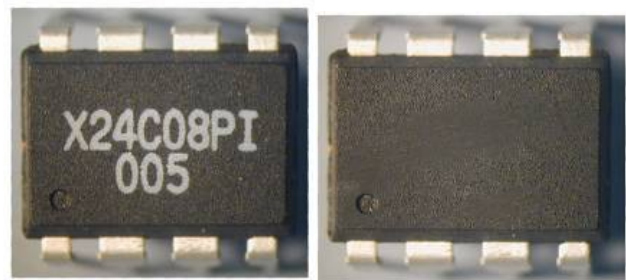
Two 8-pin DIP packages were received for analysis. Acetone testing completely removed all markings and the textured surface, indicating the part has been black topped.

Component As-Received

After Solvent Test

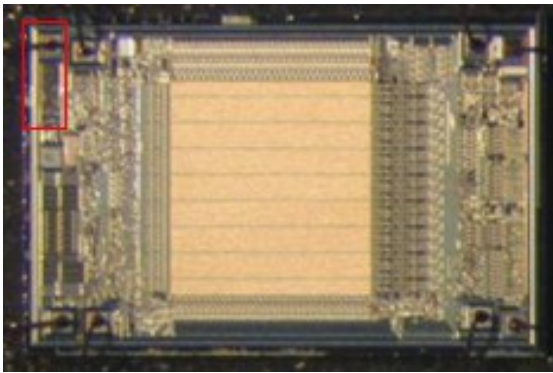
Decapping found that both components had identical chips, marked with the Xicor logo and the lettering "X24C08A."

Chip Surface

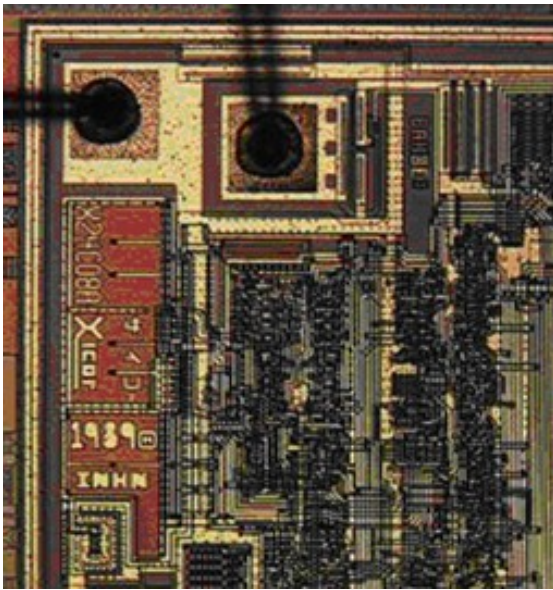
Chip Markings Close-Up (Red Square)

This marking partially corresponds to the external part number, so the remarking may reflect a different Xicor part number variant or date code.

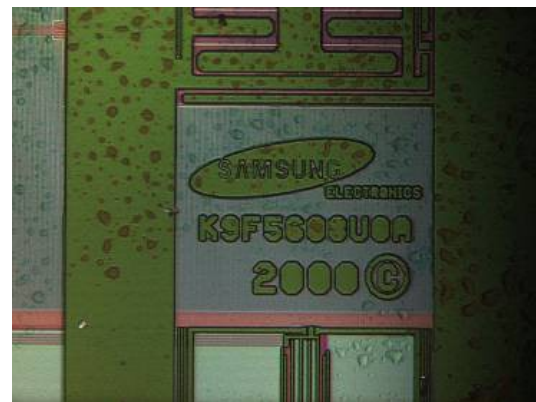
Chip Markings Close-up (red square)

Close inspection revealed Samsung part number K9F5608U0A. This is a valid Samsung part number for 32M x 8 Bit NAND Flash Memory. The package marking (K9K1208U0A) is for 64M x 8 Bit NAND Flash Memory. These memory chips are 32M parts that have been remarked as 64 M.

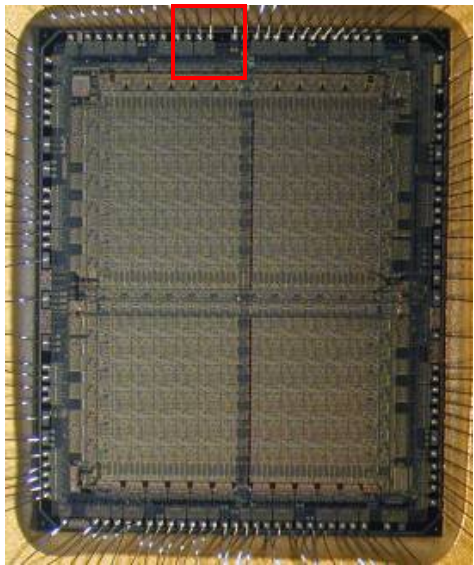
Chip Surface

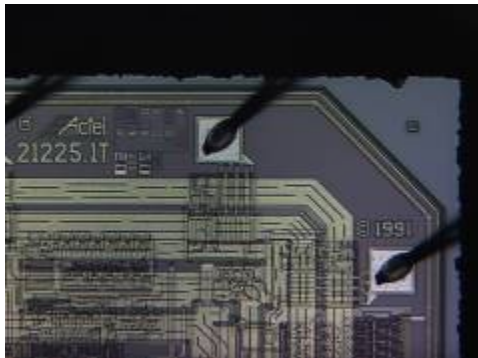
Top Edge Close-Up (Red Square)

The alpha-numeric “21225 partially matches with the external component marking.

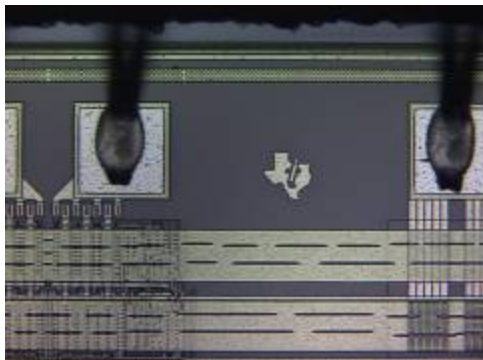
Upper Right Corner Close-Up (Red Square)

Die markings also include “Actel” and the Texas Instruments logo. TI manufactured ICs for Actel in the 1980’s, and sold the manufacturing operation to Actel in 1995. There are no indications that this is a counterfeit component.

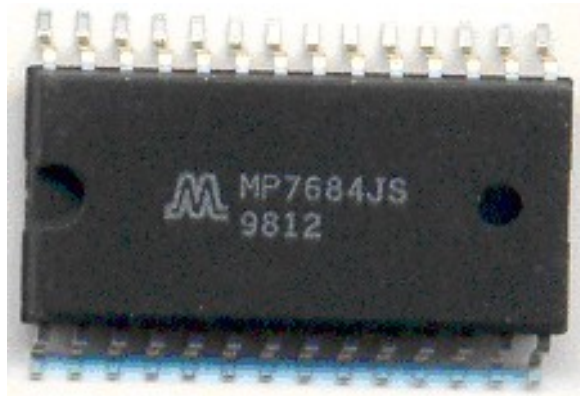
Date Code 9812 Top Side Markings

The packages showed no signs of tampering, and all part markings passed solvent testing.

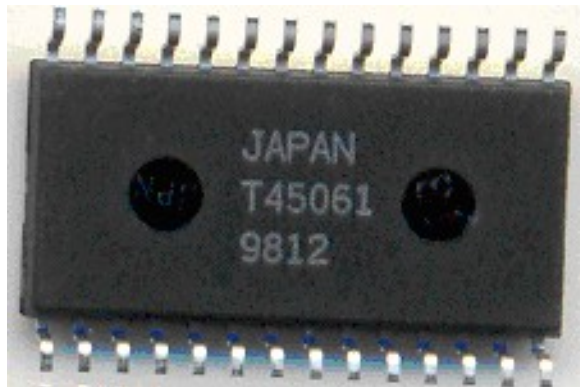
Date Code 9812 Bottom Side Markings

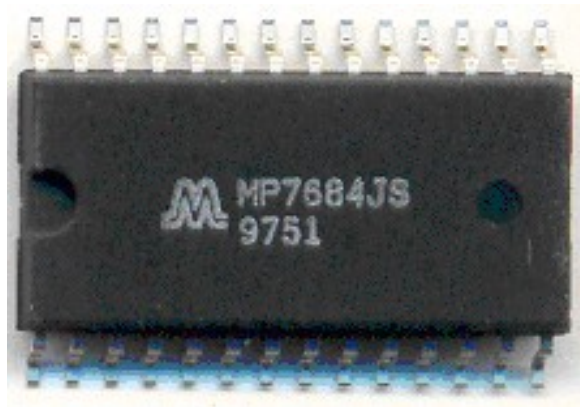
Date Code 9751 Top Side Markings

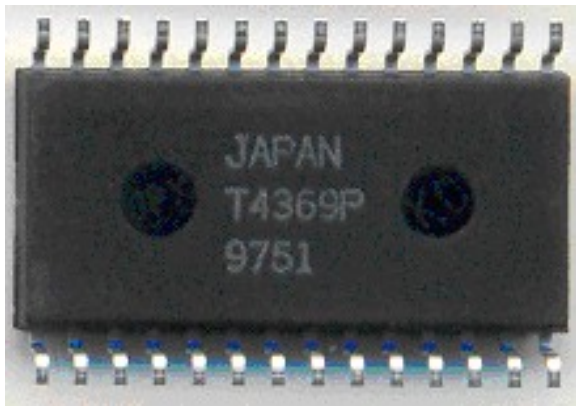
Date Code 9751 Bottom Side Markings

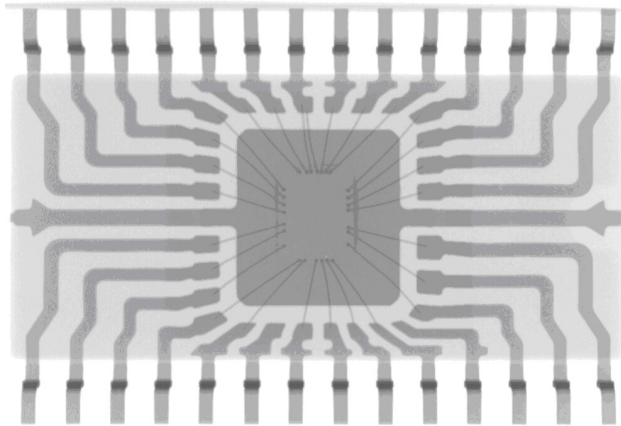
X-ray inspection verified that the lead frames were identical, with all bond wires intact

X-ray Image - 9812 date code

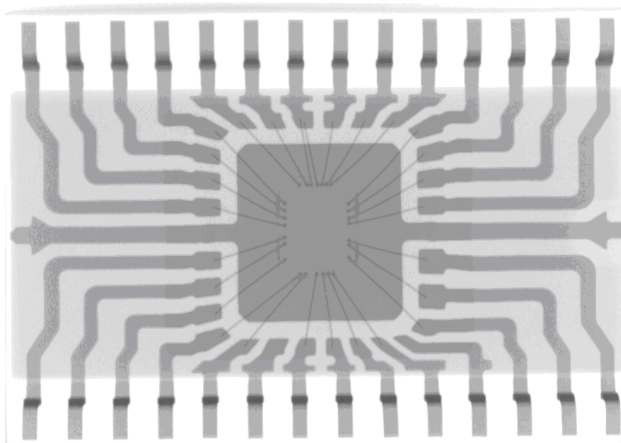
X-ray Image - 9751 date code

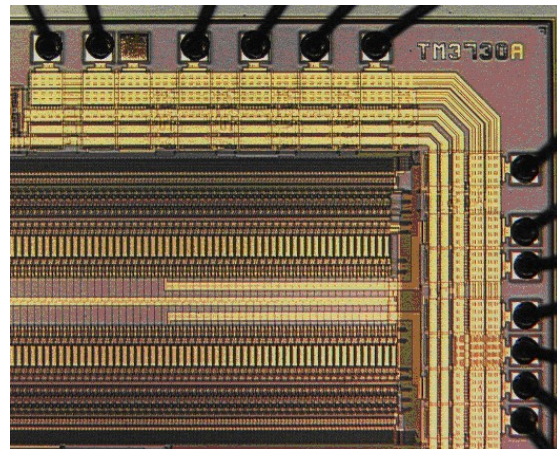
After decapsulation, all parts were found to have identical die markings, which were located in the upper right and lower right corners.

Chip Surface – Upper Right Corner

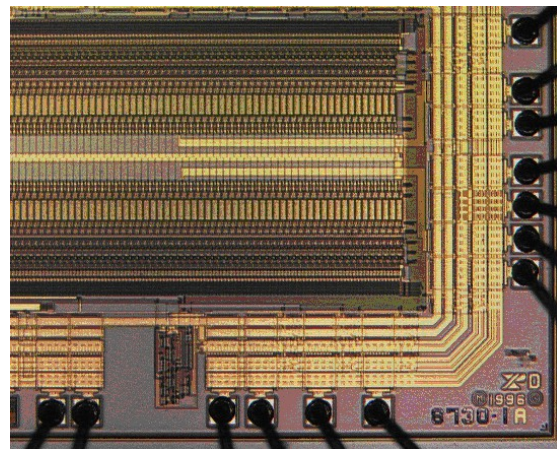
Chip Surface – Lower Right Corner

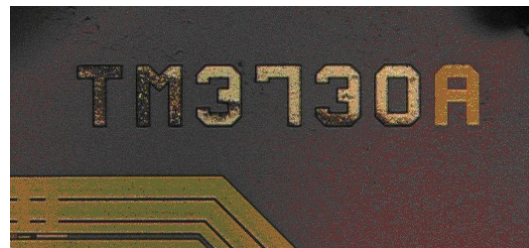
Chip Markings Close-up – Upper Right Corner

The die surface is marked with an Exar logo, and the date 1996. Since Exar acquired Micro Power Systems (represented by the “M” logos on the package and the die) in 1994, these markings are consistent with authentic Micro Power Systems parts.

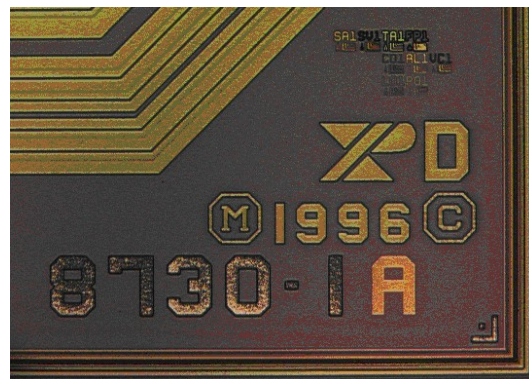
Markings Close-up – Lower Right Corner

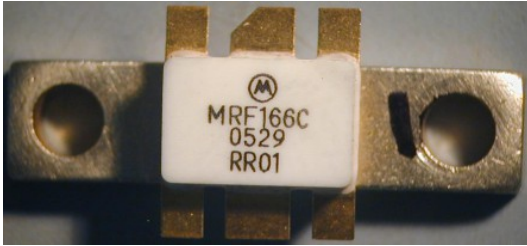
The packaging and external markings on all parts were identical.

Component As-Received

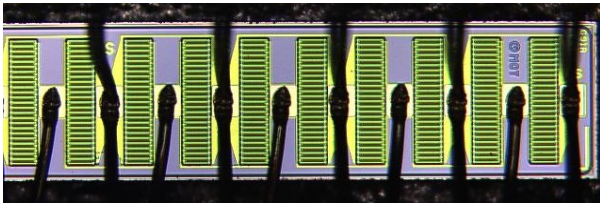
After the components were decapped, sample number 3 was found to have the Motorola logo and “MOT.”

Sample 3 Chip surface

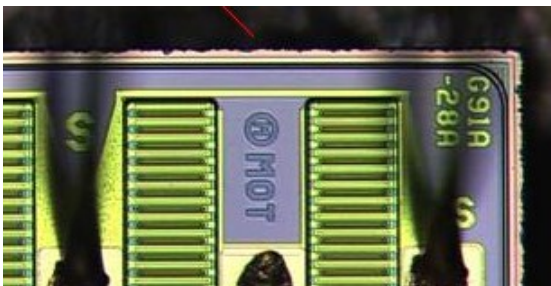
Close-up of logo and lettering

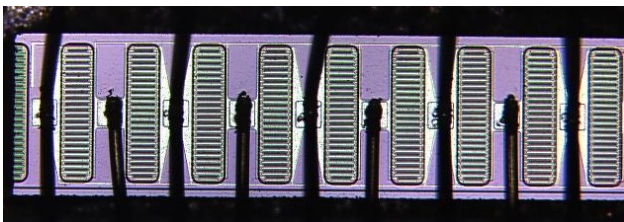
The other samples were found to have identical dies, with a different surface color (as compared to sample 3), and no logo or lettering.

Sample 2 Chip surface

Samples 2 and 3 are counterfeit components.
